Machinery Messages

Case History

Reactor recirculation pump shaft crack

Grand Gulf Nuclear Station

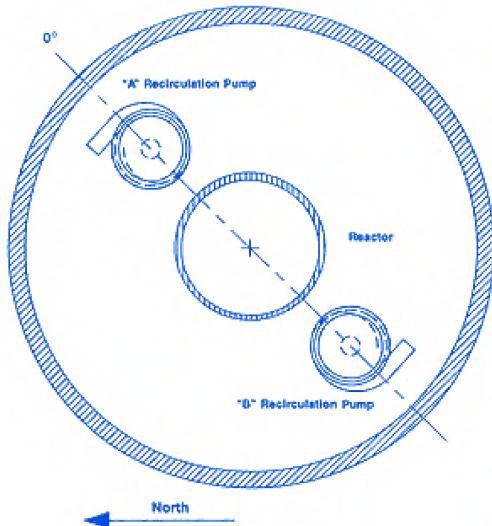
Figure 1
Reactor recirculation pump showing
vibration transducer orientation

The general arrangement of the A and B reactor recirculation pumps is depicted in Figure 1. This figure also defines the angular locations of the vibration transducers for the two rotor systems with respect to an arbitrary 0 degree reference.

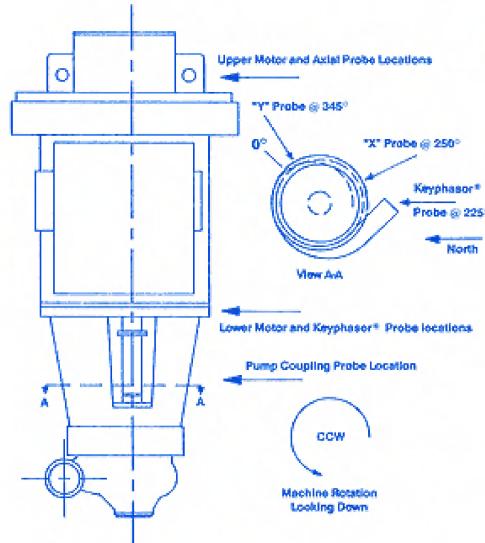
Figure 2
Reactor recirculation pump showing probe location

Additionally, each pump is equipped with a single axial position transducer, observing a balance ring near the upper motor bearing and a Keyphasor® transducer located near the lower motor bearing (Figure 2). The Keyphasor® transducer signal was used as the reference for all phase data presented in this article.

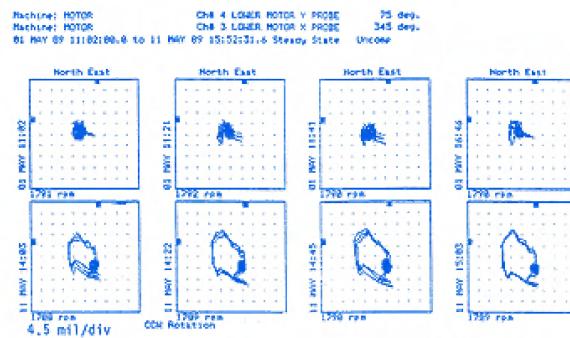
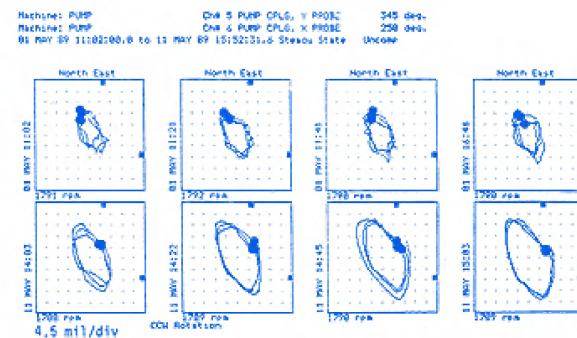
Figure 3

However, by viewing the 11 May unfiltered Orbit at the pump coupling, one can conclude that the radial side load acts at 45° . Initially, the unfiltered Orbit is elliptical (Figures 3&4). Over the following two hours, the elliptical shape of the Orbit began to truncate on its east side, indicating the shaft was preloaded in that direction.

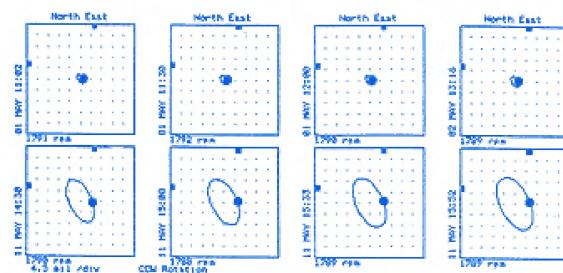
Figure 5

Figures 3 through 10 show that the unfiltered, 1X filtered and 2X filtered shaft Orbit had not changed in either magnitude or phase through 2 May. However, the data for 11 May clearly shows that significant amplitude and phase changes had occurred in all orbital presentations. ►

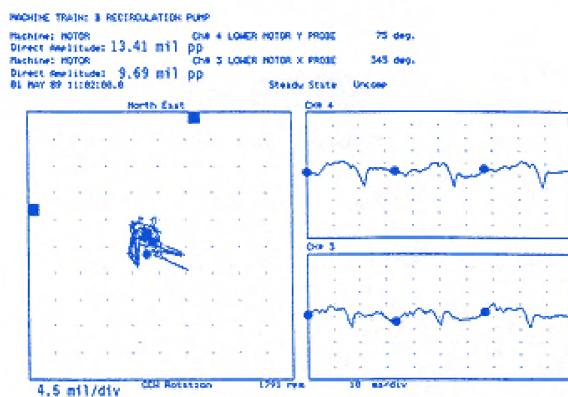
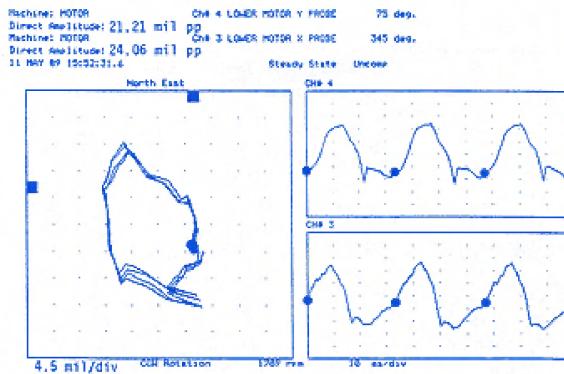
Figure 9
Orbit/Timebase data prior to final crack propagation

Figure 10
Orbit/Timebase data during final crack propagation

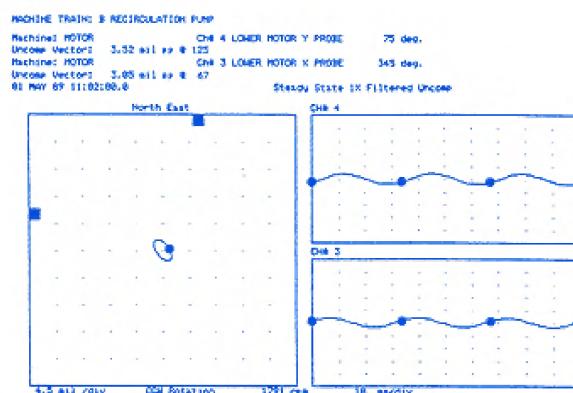
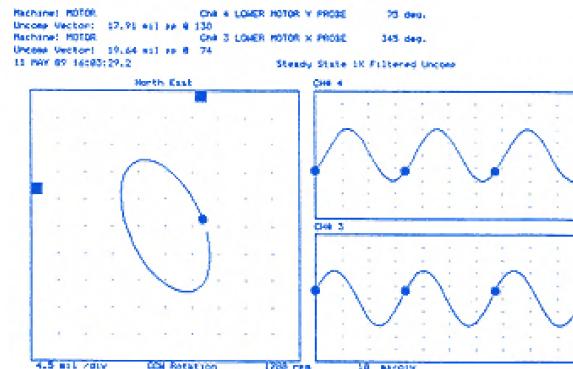
Figure 11
Orbit/Timebase data prior to final crack propagation

Figure 12
Orbit/Timebase data during final crack propagation

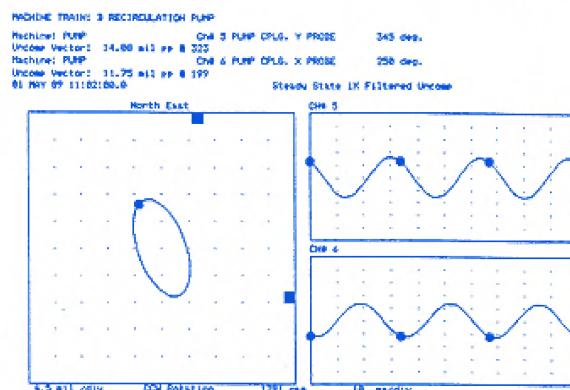
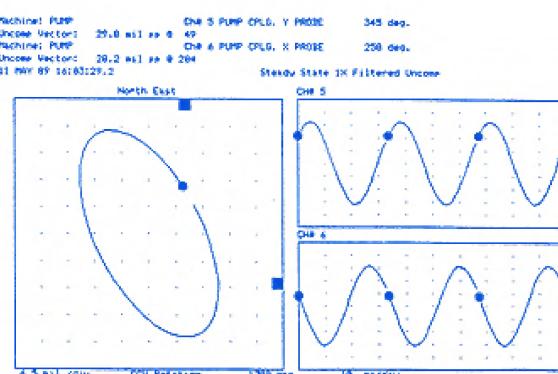
Figure 13
Orbit/Timebase data prior to final crack propagation

Figure 14
Orbit/Timebase data during final crack propagation

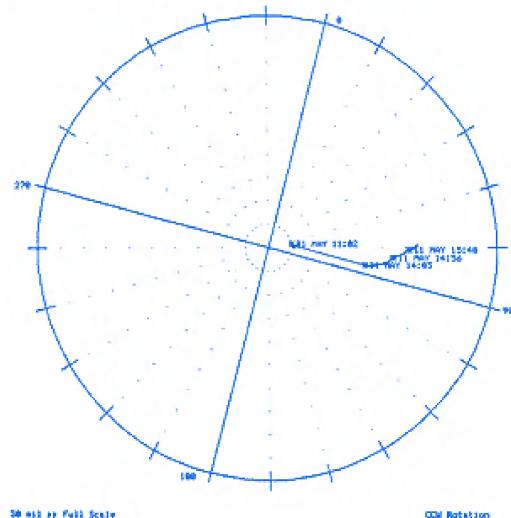
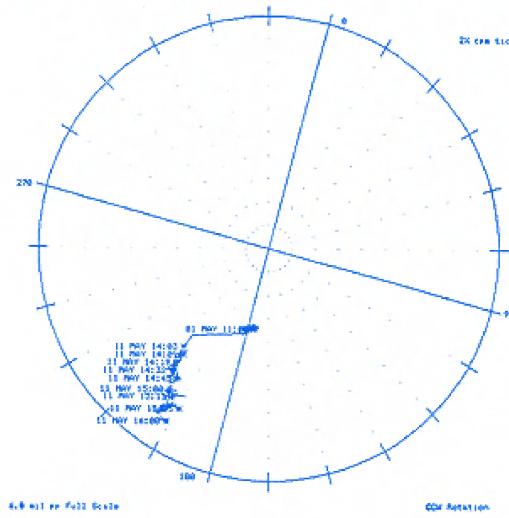
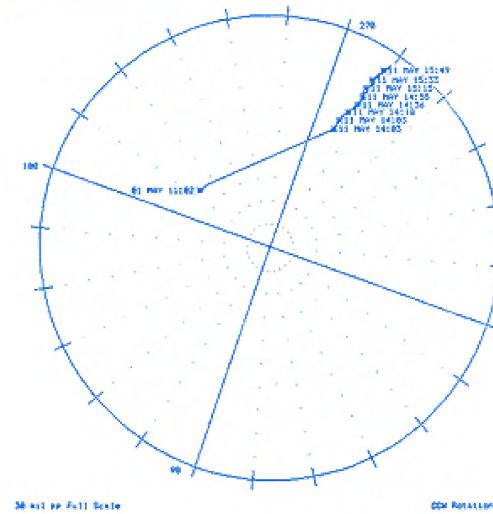
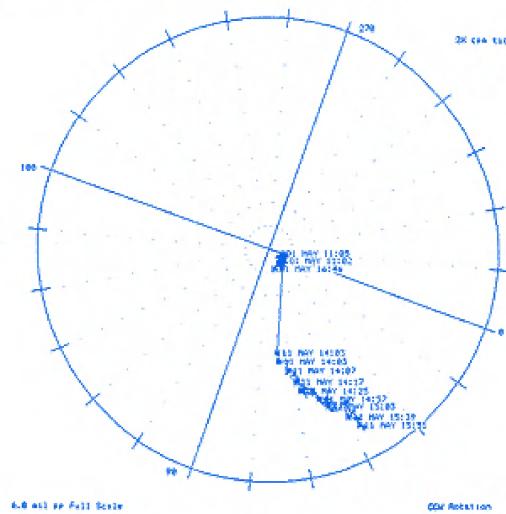
Figures 15 through 18 are Amplitude and Phase versus Time (APHT) plots for both the 1X and the 2X vectors. At all locations, the amplitude and phase information was constant during the 26 hour period spanning 1 and 2 May. However, significant and continuous changes in both the 1X and 2X vectors were noted during a two hour period on 11 May.

It is therefore necessary to monitor the 1X and 2X steady state vectors on a continuous basis to establish the normal Acceptance Region on the APHT plot. Additionally, alarms are necessary in order to alert the user to amplitude and phase deviations outside of the normal Acceptance Region. When either the 1X or 2X vector moves outside the established Acceptance Region, further diagnosis becomes necessary. Continuous changes in the 1X and 2X vectors (Figures 15 through 18) are key indicators of the presence of a shaft crack.

Figure 15
Amplitude and Phase versus Time Plot for 1X vector

Figure 16
Amplitude and Phase versus Time Plot for 2X vector

Figure 17
Amplitude and Phase versus Time Plot for 1X vector

Figure 18
Amplitude and Phase versus Time Plot for 2X vector

To properly monitor a rotor system for a shaft crack, it is necessary to continuously monitor and trend the overall amplitude, the 1X amplitude, the 1X phase, the 2X amplitude and the 2X phase and to be able to alarm on any one or any combination of these variables. If these variables had been trended at Grand Gulf, all five variables, as observed by *both* pump coupling proximity probes, would have been in alarm on 11 May.

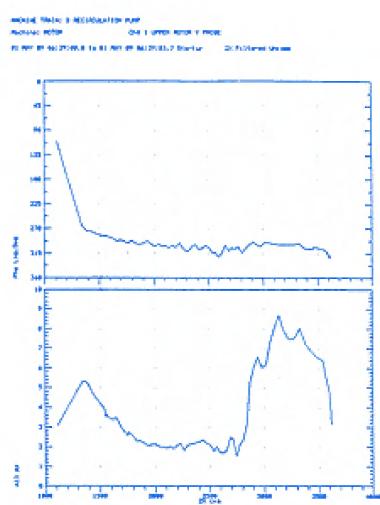
Startup data acquired on 1 May indicated that the rotor system's first balance resonance occurred at 1360 cpm with additional resonance responses observed at 2540 cpm, 3550 cpm and 6550 cpm. The resonances were documented by observing the 1X, 2X and 5X vibration response during the startup period. Figure 19 is the 2X response. Figure 20 is the 5X response at the pump coupling. The resonance responses are all significant as they not only indicate at what frequency the rotor resonances were observed, but also that the 2X and 5X resonance responses are in excess of 2.0 mils ($51 \mu\text{m}$) peak-to-peak and in some instances are in excess of 4.0 mils ($102 \mu\text{m}$) peak-to-peak.

The startup data for the B pump shows significant 2X and 5X resonance activity. The transient 2X and 5X activity observed on the B pump is the direct result of reduced shaft stiffness due to the existence of the crack during startup on 1 May.
